Final report: Construction of classrooms at El Pozón School.

Students and teachers celebrated the big opening of their new classrooms on April 28th, 2026.

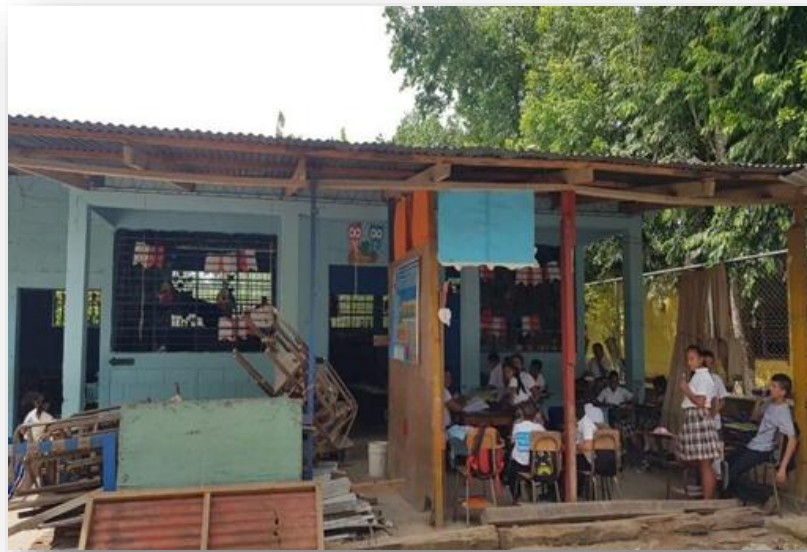
This photo shows the state of the school before the classrooms were built. It clearly shows how, due to overcrowding, students were taking classes outside and in makeshift corrugated metal sheds.

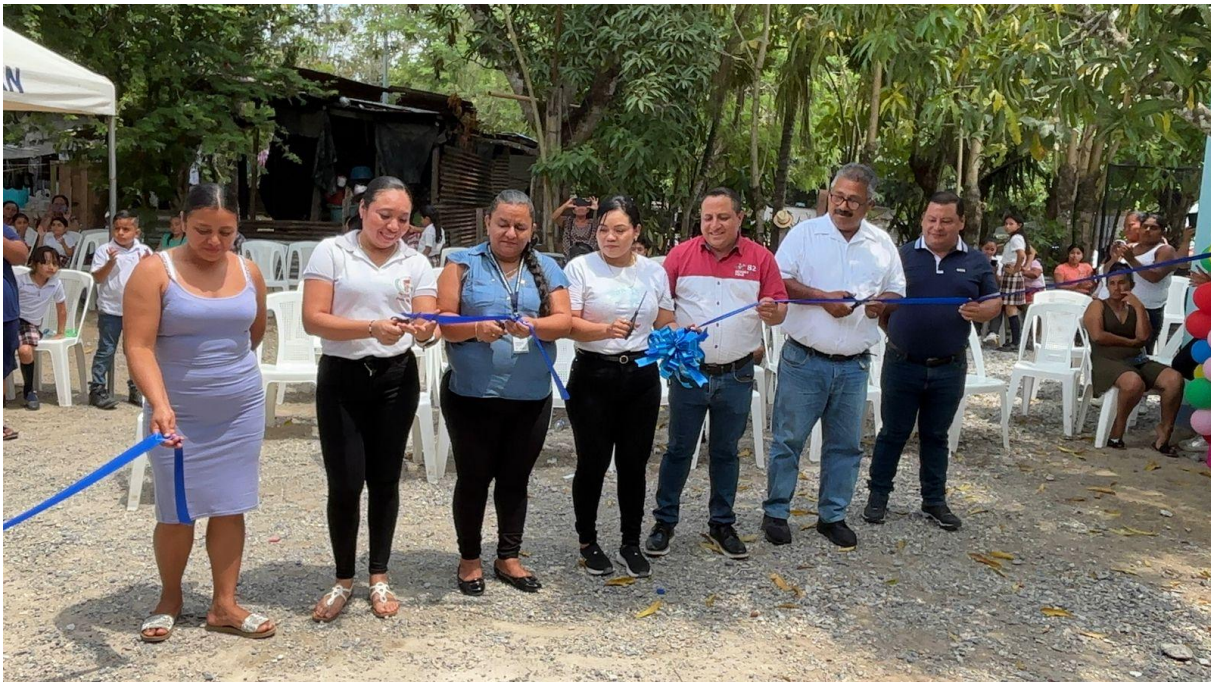
Educational staff of El Pozón School, along with parents, cutting the ribbon at the inauguration ceremony.
